Manhole Inspection Summary

Manhole # S31S1_001MH

Insp Date: **2/18/08 1:27 PM**

Location Address: **3502 Round Rd.**

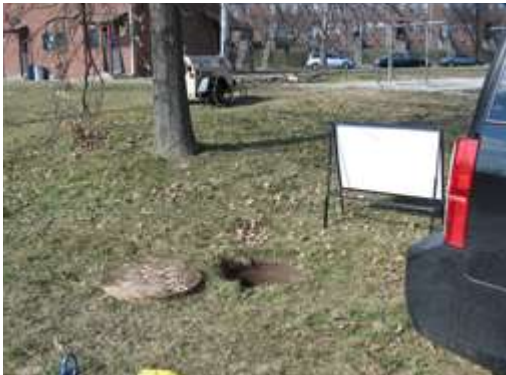
Location View

Building 3502

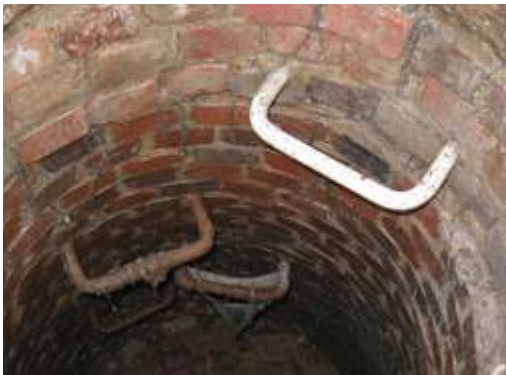
Steps

Count: **4** Missing: **0** ☒ Corroded

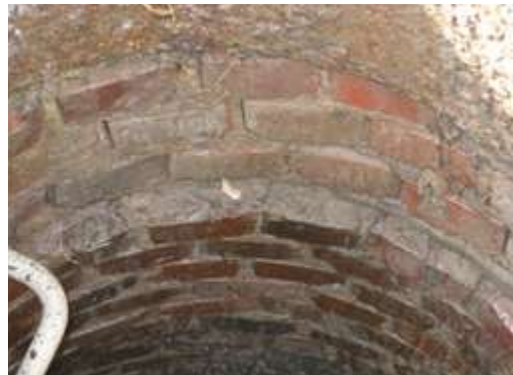
Defect 1

Infiltration: ☐ None ☐ Joint ☐ Cracks ☐ Mortar ☐ Roots ☒ Wall

Wall

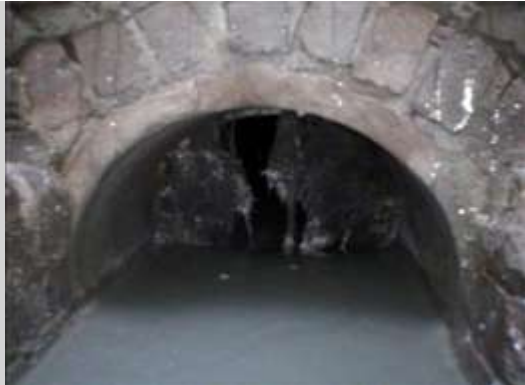
12 O'Clock Outflow

15 in. Circular Gravity Sewer
Pipe Out @ 12 O'Clock

Infiltration: **None** Pipe Seal Cond: **Sound**

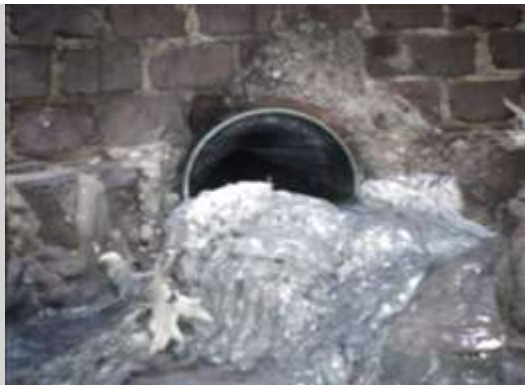
3 O'Clock Inflow

8 in. Circular Service Sewer
Pipe In @ 3 O'Clock

Infiltration: **None** Pipe Seal Cond: **Sound**

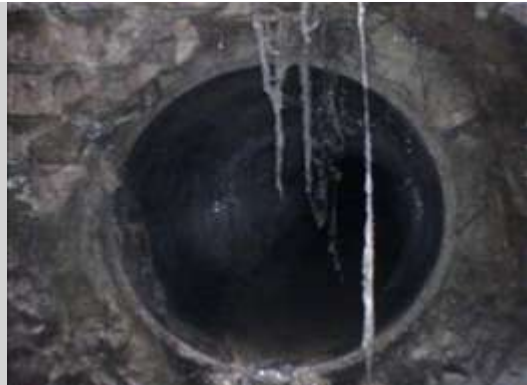
9 O'Clock Inflow

Pipe In @ 9 O'Clock

Infiltration: **None** Pipe Seal Cond: **Sound**

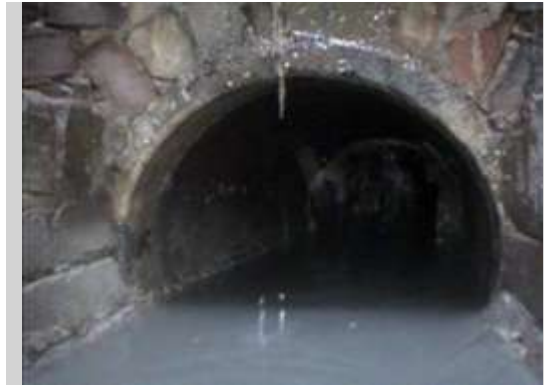
Drop In @ 9 O'Clock

Drop: **Outside** Rod and Bar

Drop Condition: **Open**
